B-Pillar Mocket/Foam Seal Repair

Jeep Wrangler Replacement Parts List

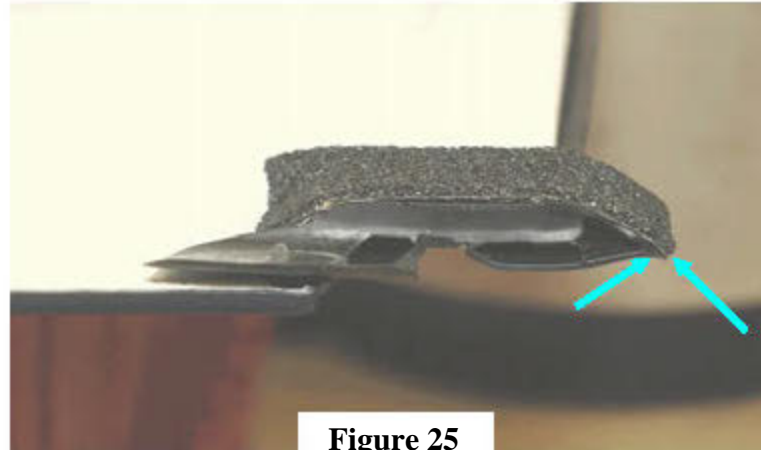
- Install **BLACK** 30 X 75 mm Foam from kit (68026937AB) along trim lines of flame tip (Figure 25)
- NOTE: Make sure foam covers butyl completely

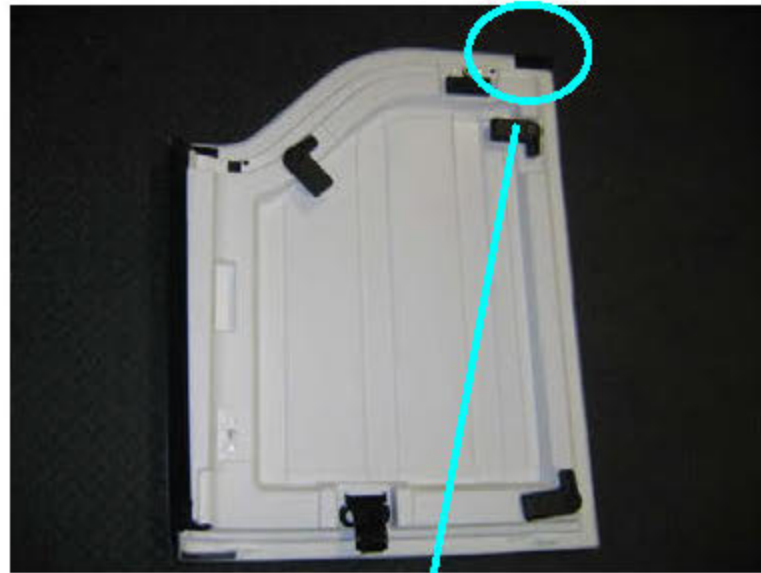
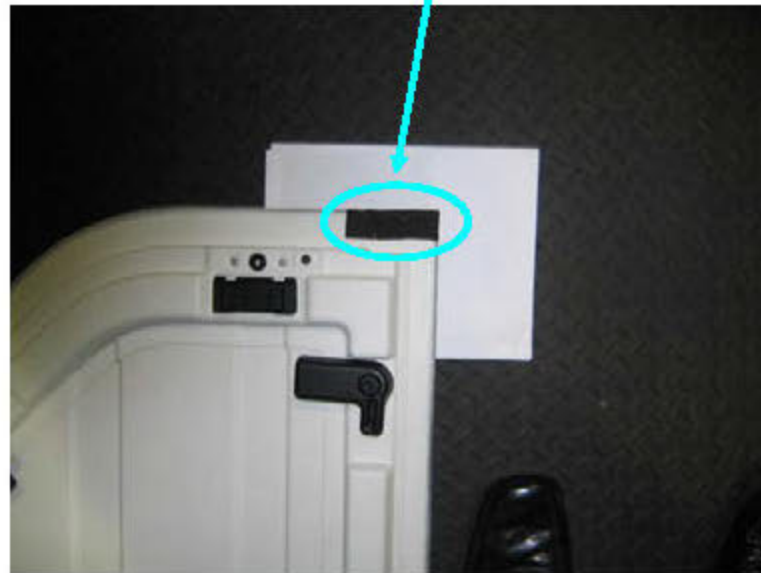
Figure 28

- Add 30 X 75 mm Black Foam from Kit (68026937AB) to cover butyl (Figure 28)
- NOTE: Make sure foam covers butyl completely

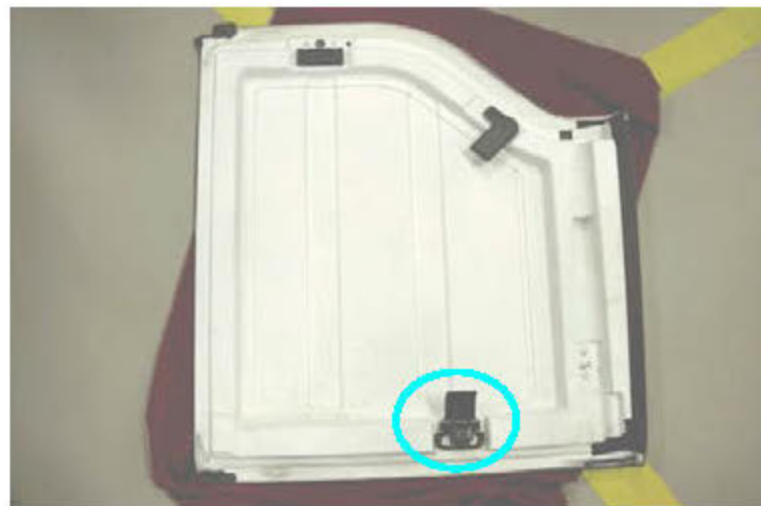
Figure 29

- NOTE: This applies to both Right and Left panels
- If the vehicle MDH is prior to 12/07/07, replace the front latches with part number 68004562AB (Figure 29)

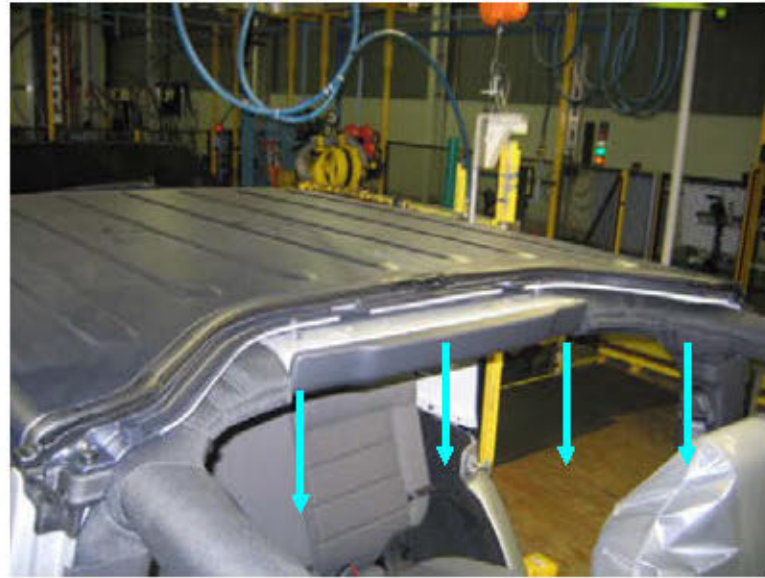
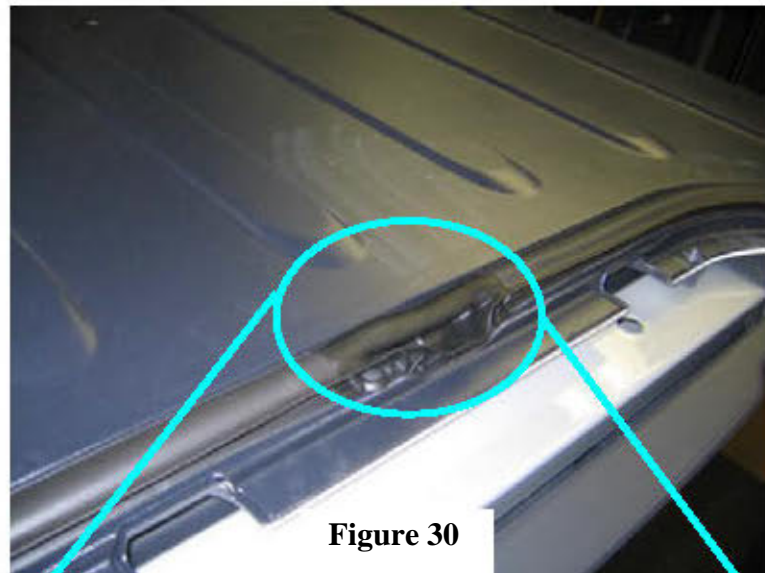
Figure 30

- Inspect for any gaps between the seal and hard top (Figure 30,31)

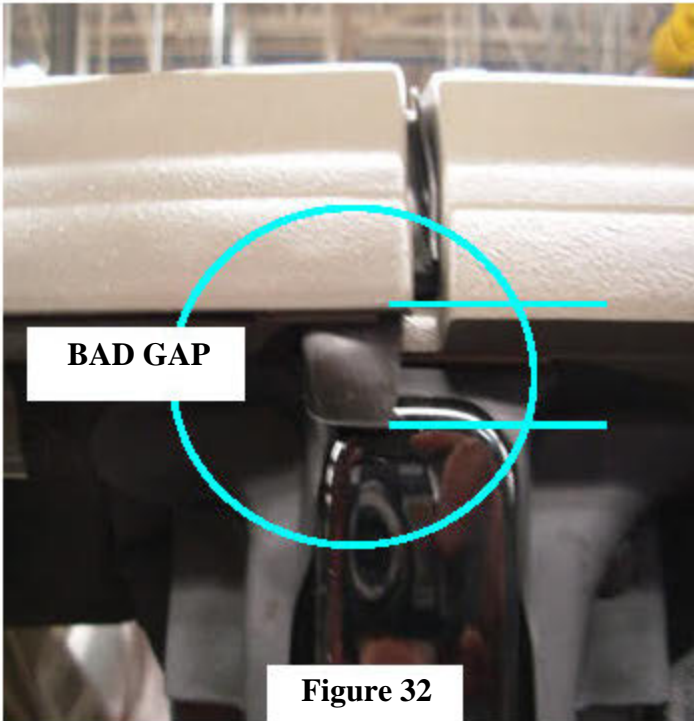
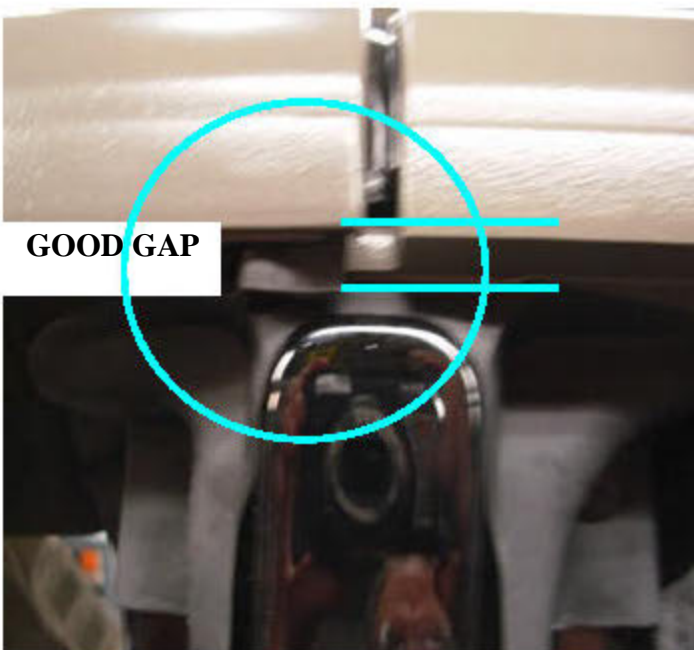
- Inspect the end molds for poor installation (Figure 32)

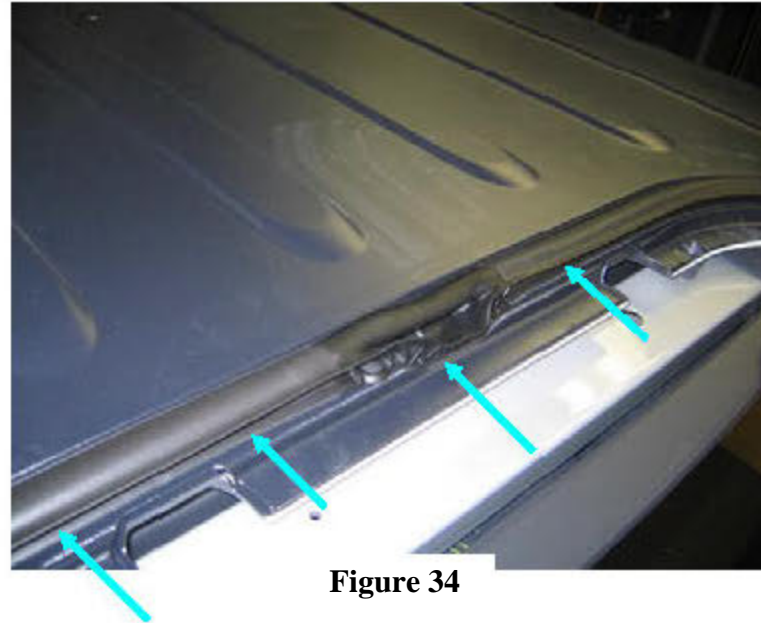
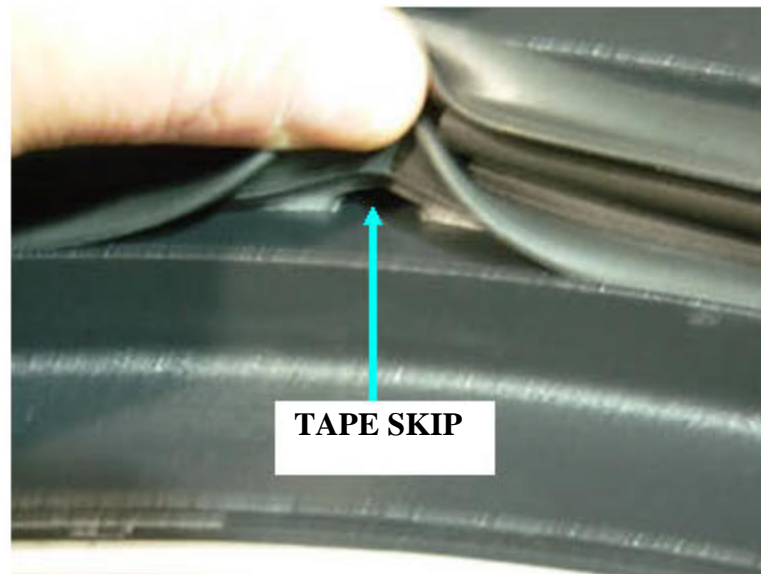
- Inspect underneath the seal for any skips with the tape/butyl along the entire seal (Figure 34 & 35).

- If there are multiple skips or the leak cannot be stopped, replace seal.
- Remove all tape/butyl and clean with alcohol prior to installation
- A rubber wheel bit can be used to remove the tape
- Pre-apply butyl (68027813AA) on hard top prior to installing the seal (Figure 36)
- It is critical that the end molds are installed correctly and sufficient pressure is applied to wet out the butyl/tape (Figure 36)

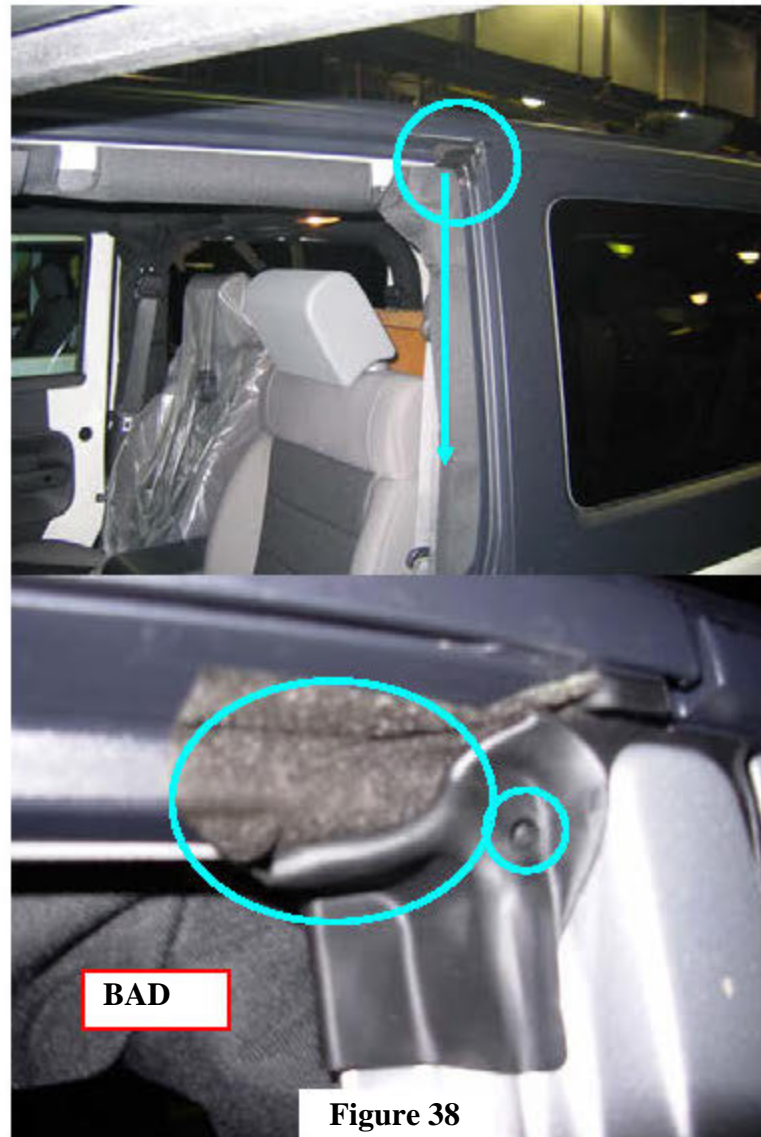
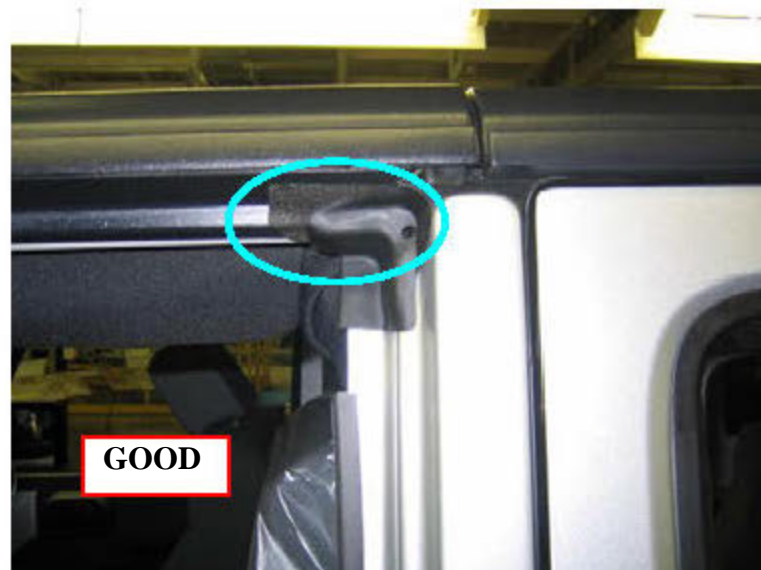
- Inspect the mocket for a rolled under condition (Figure 38)
- Inspect the mocket for a missing drain hole

- If either of these conditions exist, replace the mocket detail (Part #:55395708/9AE)
- Reinstall the panel or side rail making sure not to distort the mocket

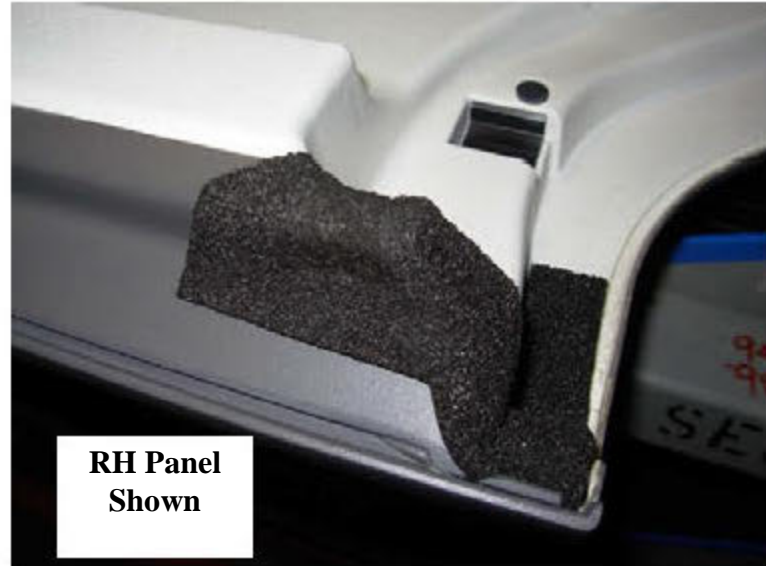
Figure 40

- If the foam is damaged or missing, replace the foam using the foam kit (68026937AB)

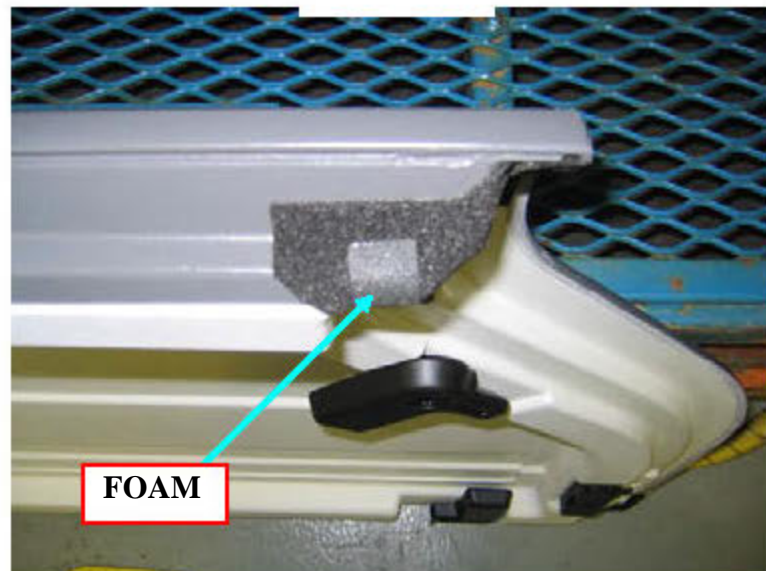
- Add a piece of foam to the freedom panel as shown in Figure 41. This foam can be created by cutting the 30 x 75mm GREY foam in half from the foam kit (68026937AB)
- Figure 41

NOTE: This foam is in addition to the foam that is already on the panel

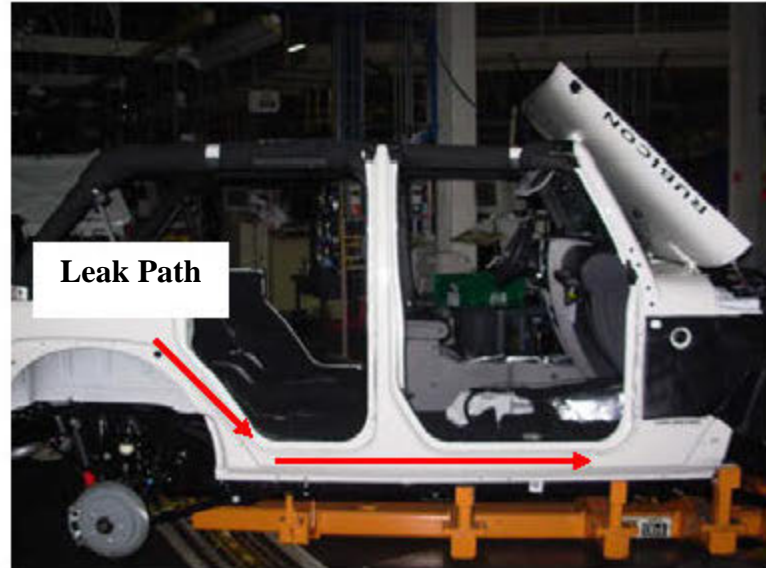
Figure 42

- Inspect the body for missing or mis-aligned tape over the hole as seen in Figure 43
- Add/Replace a tape patch over the hole

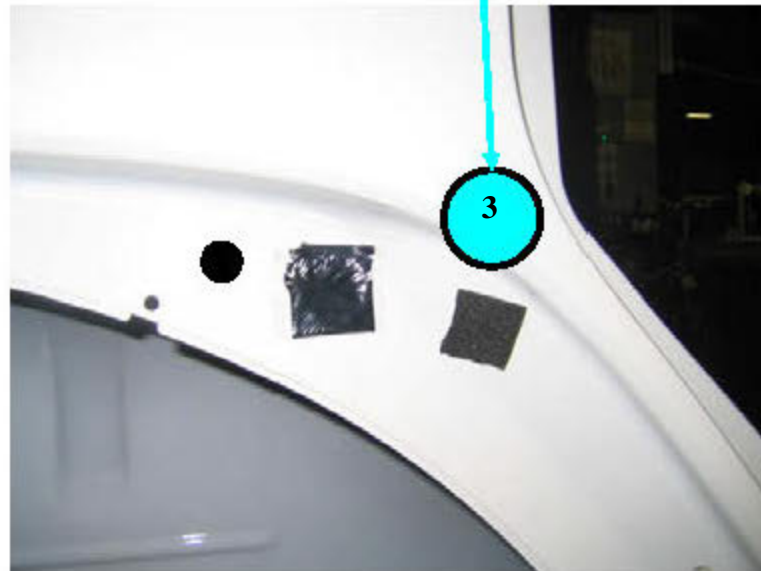
Figure 45

- Cut the BLACK 30 x 75 foam from the foam kit (68026937AB) in half and apply over this hole (Figure 45)
- Make sure the foam does not extend past the flare trim line (appearance issue)
- Re-install flare

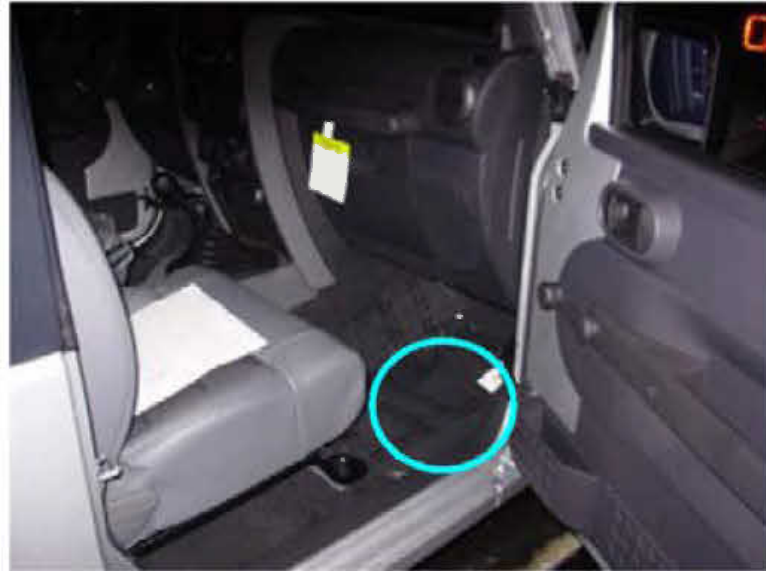
Figure 46

- This repair procedure is applicable when water is evident on the:
 - Front floor (wet carpet)

NOTE: These leaks can be diagnosed by applying a hose in the cowl area (Figure 47).

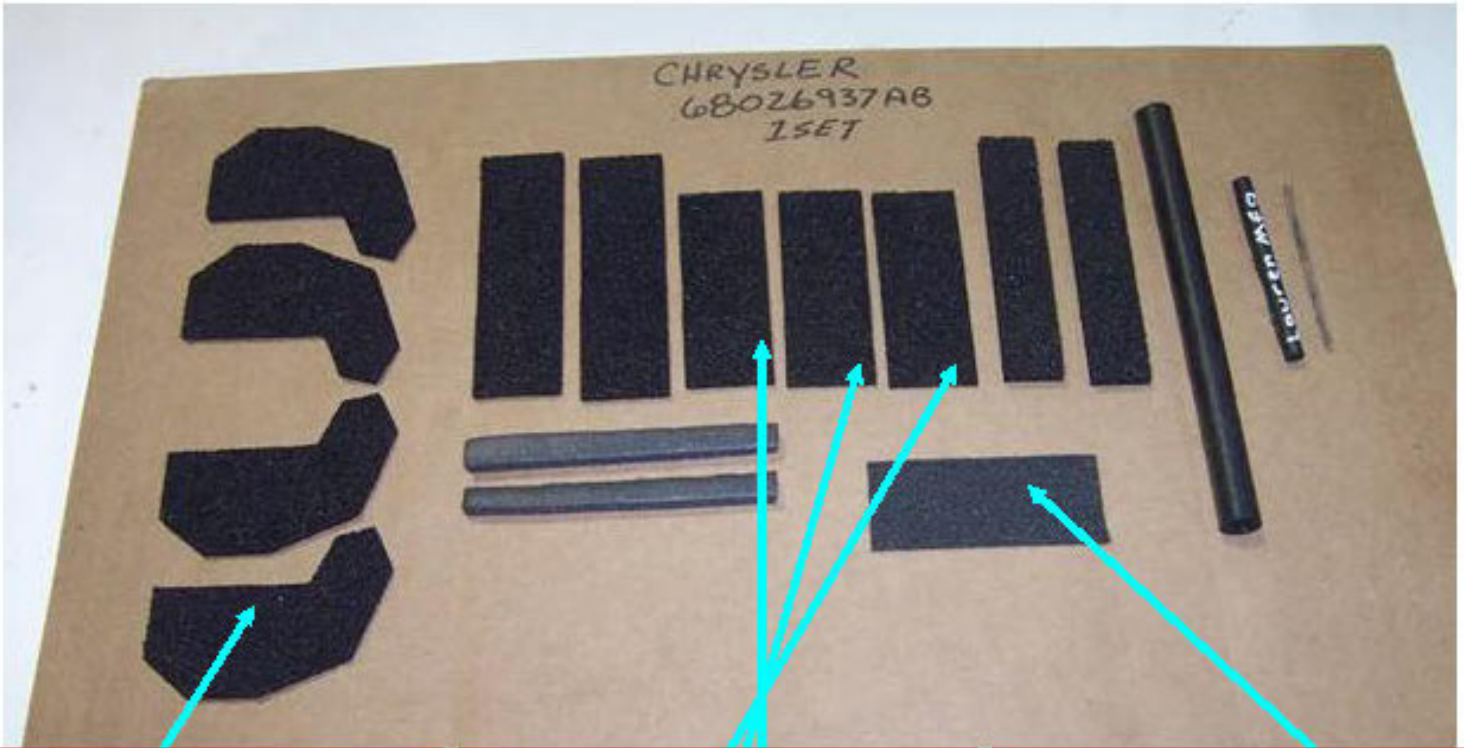
Foam Kit: 68026937AB

A/B-Pillar Foam

30 mm x 75mm BLACK Foam

30 mm x 75mm GREY Foam
